Integration of Groundwater Potential and Irrigation Water Quality at Micro Level in Tannery Polluted Areas

Abstract

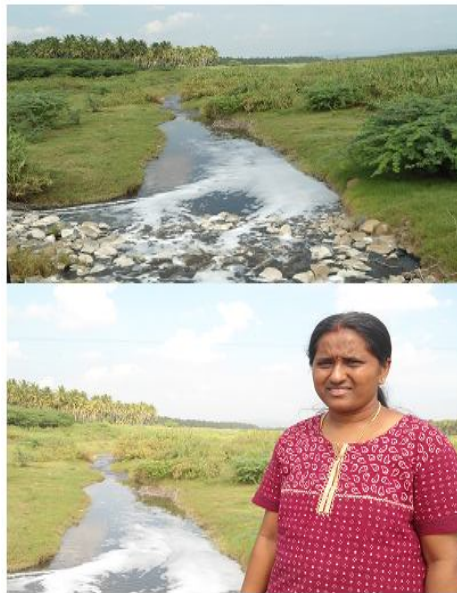
Fig.1a: Tannery effluent flowing into the Palar river at Vadacheri Crossway

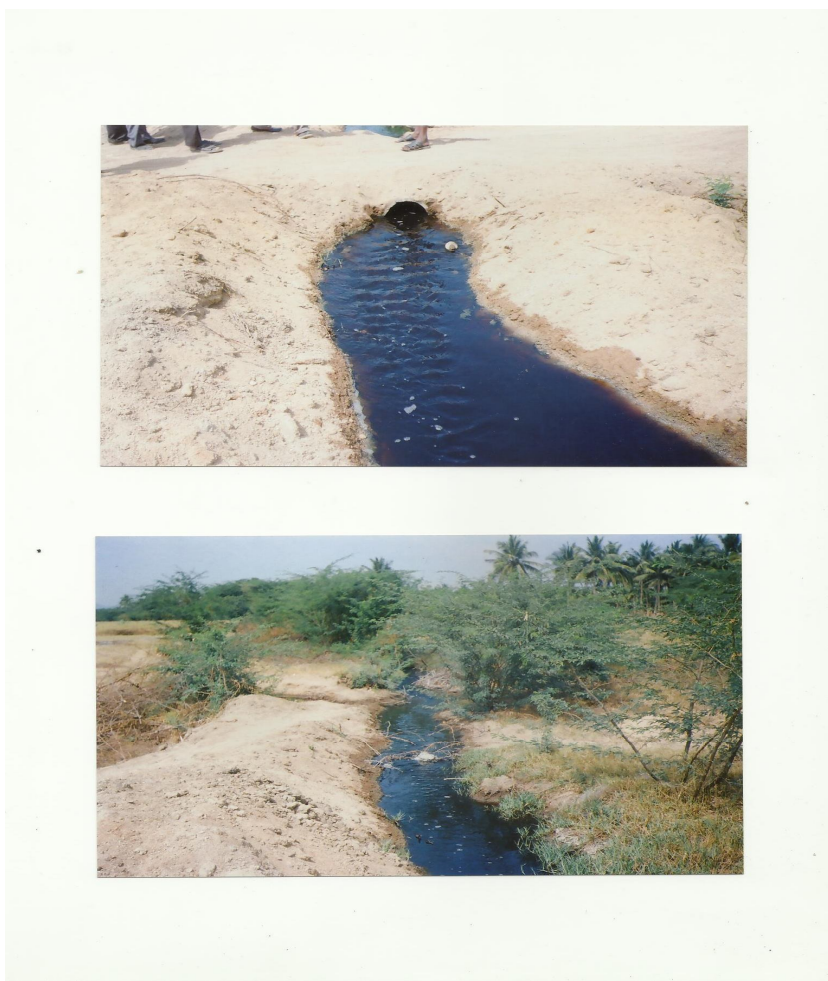
Fig.1b: Tannery Effluent Flowing in the River at Periyavarigam

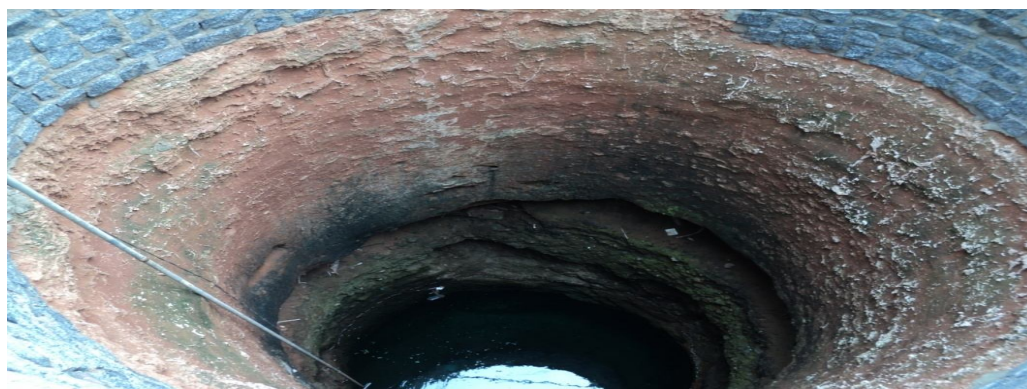
Fig.11: Depth of weathering in the observed well at Periyankuppam village (Long 78.670 Lat 12.752)

The depth of weathering is identified as 18 m to 25 m below ground level in most of the study area and verified during field visits (Fig 11-13). The zone with thick overburden and fractured bedrock are classified as having high groundwater potential.

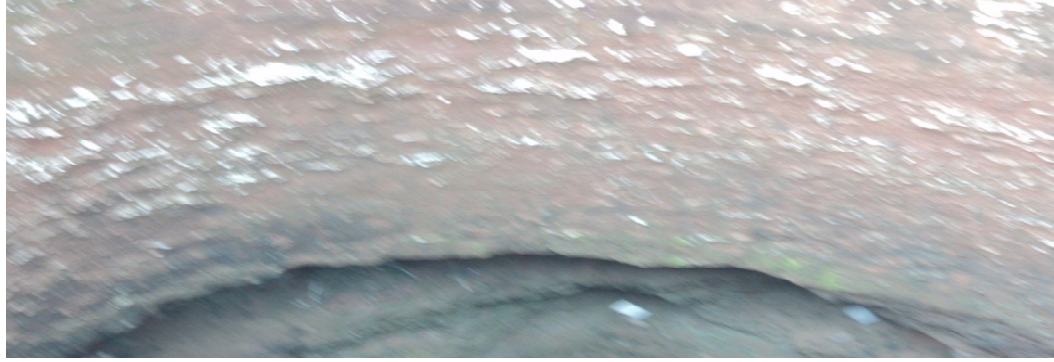
Fig. 13: Water seeping into the well in Vadakarai village (Long 78.673 Lat 12.738)
