## Assessment of the environmental reality in Alharfiyin in the city of Najaf, Iraq

This research evaluates the environmental conditions in the Harfiyin neighborhood of Najaf, Iraq, focusing on solid, liquid, and gaseous pollutants from industries. A field survey revealed significant waste, particularly solid waste from factories, and a large landfill contributing to air pollution. The presence of smoke, fumes, and toxic gases affects residents' health. Laboratory tests confirmed high levels of pollutants in the soil. Four samples were collected to assess the environmental impact. The results show a significant presence of solid waste, in line with international standards.

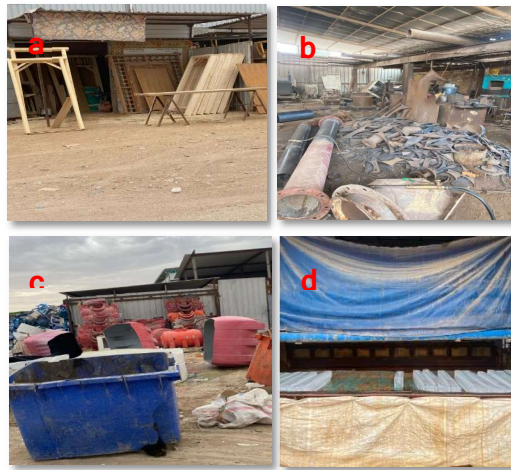
**Figure 1** a.Carpentry Laboratories, b.Aluminum laboratories, c.Plastic factory, d.Ice factory

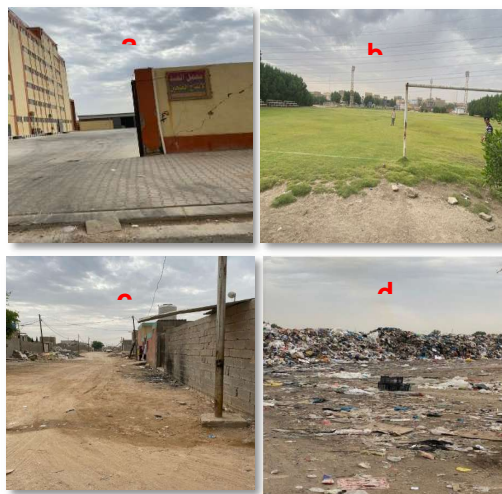
Figure 7 a. Flour Factory, b. Playground, c. Residential houses, d. Landfill

Waste from these factories is disposed of in landfills due to its potential hazards. Basic Facilities in Al-Harfani Neighborhood: The neighborhood includes residential units and a recreational yard (Figs. 2a-d). There is one low-quality restaurant for factory workers, and most residents rely on nearby restaurants. The area has a football field where children play, but houses at the end of the neighborhood suffer from poor construction. Residents face health issues, including bronchial diseases and cancer, as well as noise pollution from factory operations (7 am–6 pm). Industrial activity in the area has declined due to cheaper imports, leading to the closure of some factories like a sewing factory. The focus is now on iron, wood, and aluminum industries. Industries and Laboratories in the study area include many of the wastes that they put near or far from factories. These wastes, in turn, increase the concentration of industrial pollutants near them. These wastes are of the following types. Represented by iron scrap, sawdust residues, waste from other laboratories and Laboratories. There is also an area in the study area that is considered a solid waste dump in very large quantities. It should be noted that the study area has solid waste in huge quantities. In addition, this place is considered a landfill for the waste of other areas. When looking at the study area, you find that solid waste constitutes more than 60% because most of the laboratories and neighboring areas produce solid waste in large quantities, which in turn affects the soil characteristics of the study area.
